DoD Corrosion Prevention and Control Program

Demonstration and Validation of a Composite Grid Reinforcement System for Bridge Decks

Final Report on Project F12-AR01

September 2016

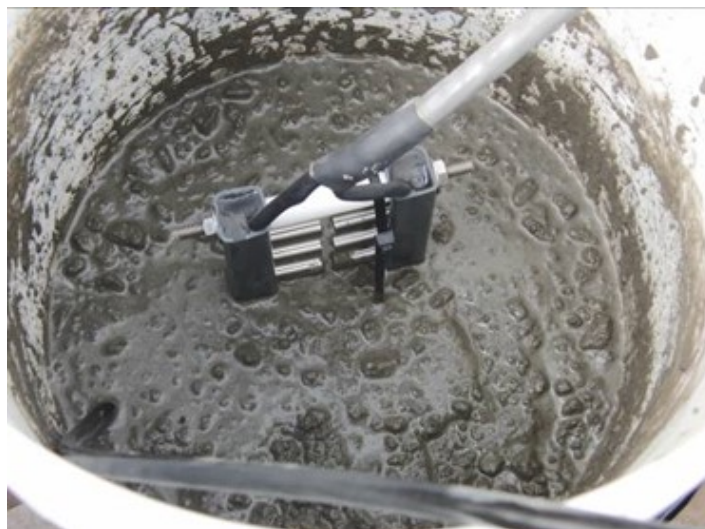
Figure B2. Coupon preparation.

A concrete coupon was formed in a 5-gallon bucket to provide a method to simulate chloride penetration. The bucket was filled approximately half-way with a concrete mix including one cup of sodium chloride. A corrosion ladder was situated in the form such that the chloride enriched concrete covered the first two set of electrodes of the chloride sensor. A corrater was also submerged in the concrete. The concrete was provided 24 hours to cure before filling the rest of the form with standard concrete. Figure B2 shows the chloride-enriched concrete covering the corrater and half of the chloride ladder sensor. Figure B3 shows the cured concrete coupon. Measurements were collected during the quarterly inspections.

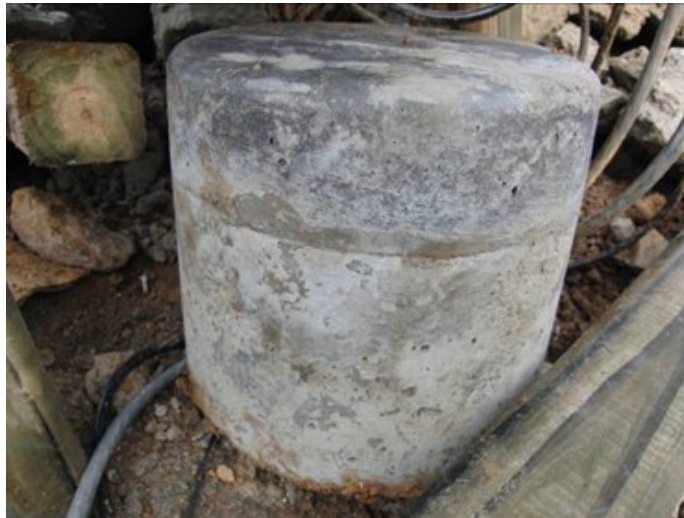
Figure B3. Finished coupon.

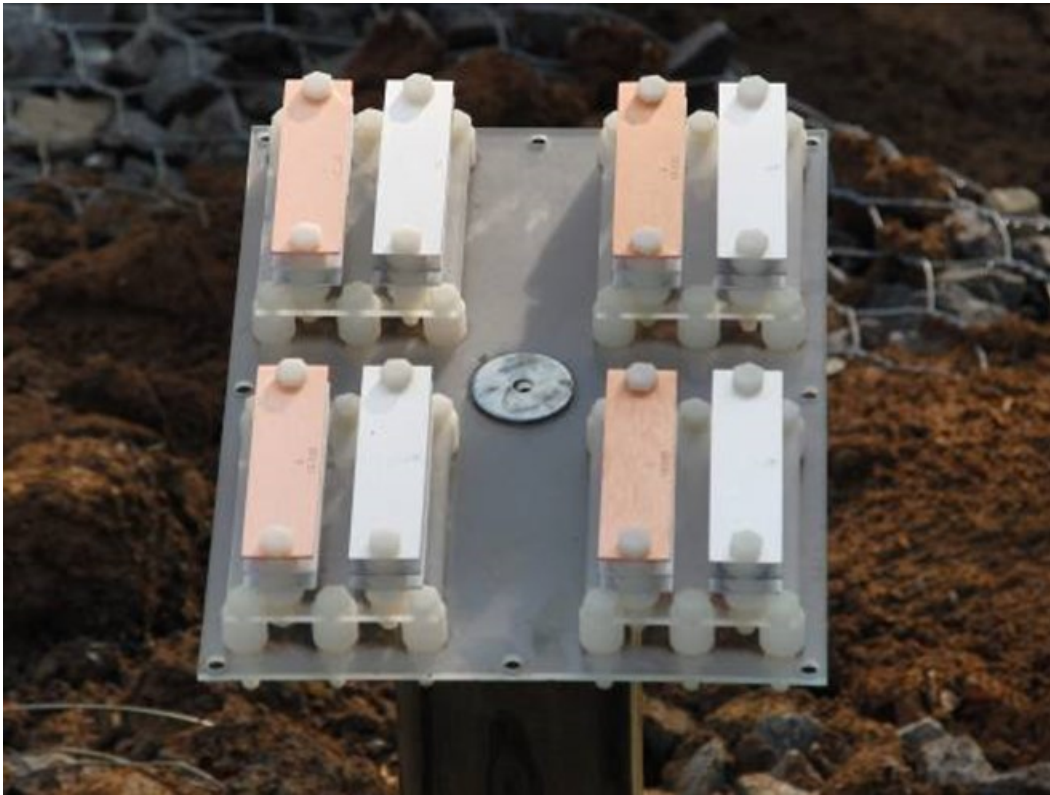
Figure B4. Atmospheric corrosion test rack.

An atmospheric coupon rack to determine the relative corrosivity of the site was installed facing 90 degrees from vertical at the bridge site (Figure B4). The corrosion coupons included silver, copper, 1010 steel, and three aluminum alloys (2024 T3, 6061 T6, and 7075 T6). The coupons measured 1 in. wide by 4 in. long by 1/16 in. thick. These coupons were collected after 6 months and 12 months of exposure. The mass of each coupon was recorded before being exposed to the test environment. The silver coupon was tested for chlorides in accordance with ASTM B825. The remaining coupons were analyzed for mass loss in accordance with ASTM G1-03.

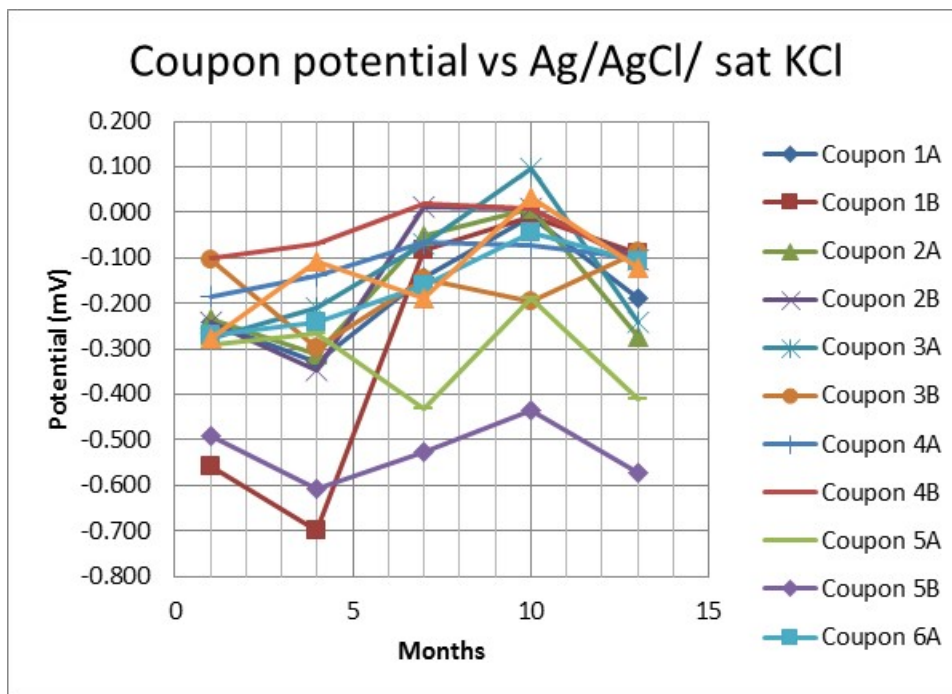
Figure B7. Coupon potentials vs. time at the six test locations on the steel-reinforced section of the bridge.

Corrosion will eventually be detected when enough chloride has reached the sensors embedded in the bridge deck concrete. The greater the amounts and frequency of deicing road salt usage, the shorter the chloride permeation time leading to significant corrosion. Even then, it could take many years. Therefore, it is recommended that monitoring of the corrosion sensors embedded in the concrete bridge deck at Fort Knox be continued (for example every 5 years), to confirm their veracity.

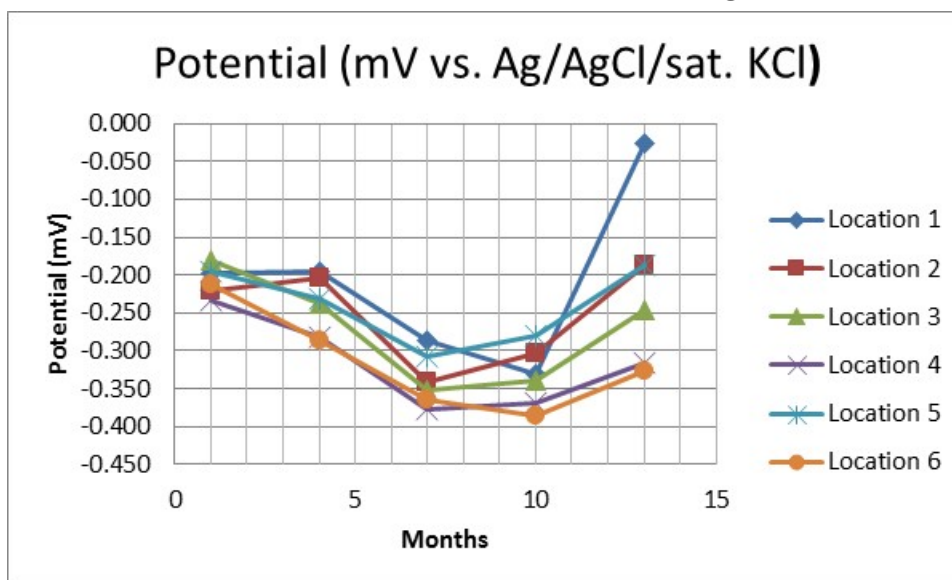
Figure B8. Rebar potential vs. time at the six test locations on the steel-reinforced section of the bridge.

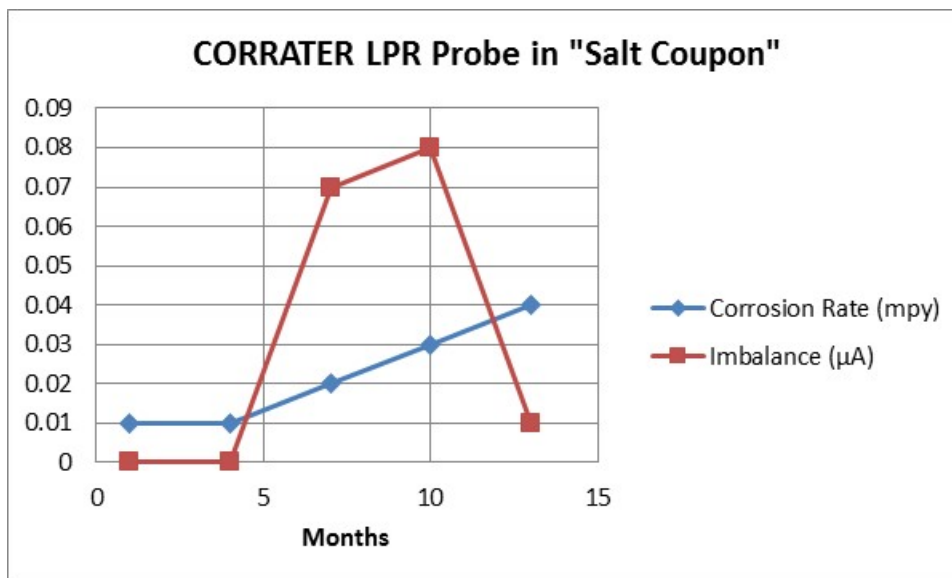
Figure B9. Corrosion rate and imbalance readings vs. time for CORRATER probe in artificially-contaminated concrete block "salt coupon."

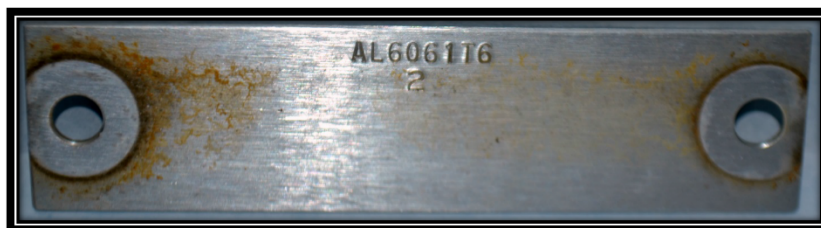
**Figure 1:** AL6061 T6 Sample prior to Corrosion Removal

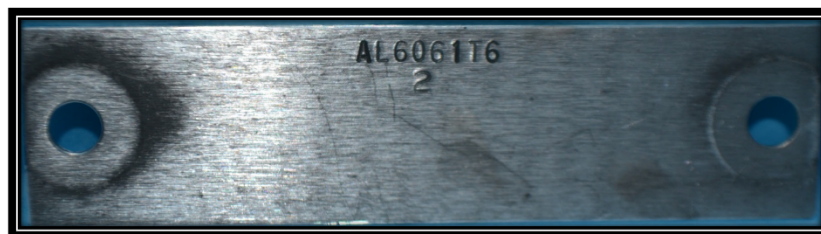
**Figure 2:** AL6061 T6 after Corrosion Removal

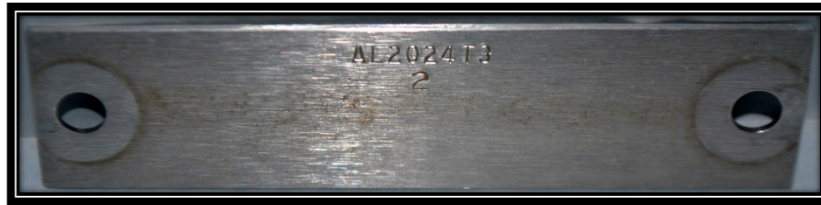
**Figure 3:** AL2024 T3 Sample prior to Corrosion Removal

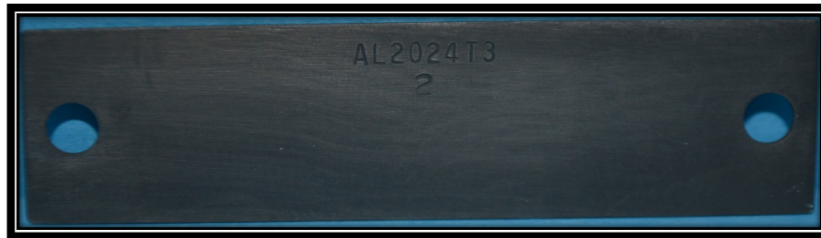
**Figure 4:** AL2024 T3 after Corrosion Removal

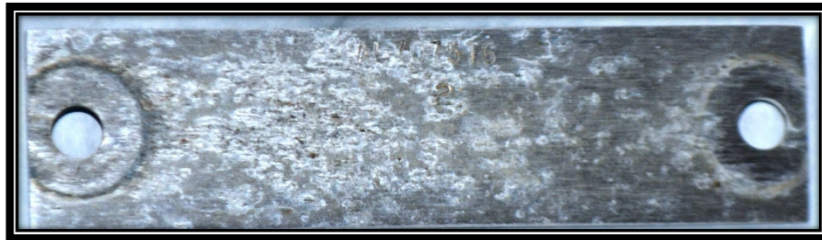
Figure 5: AL7075 T6 Sample prior to Corrosion Removal

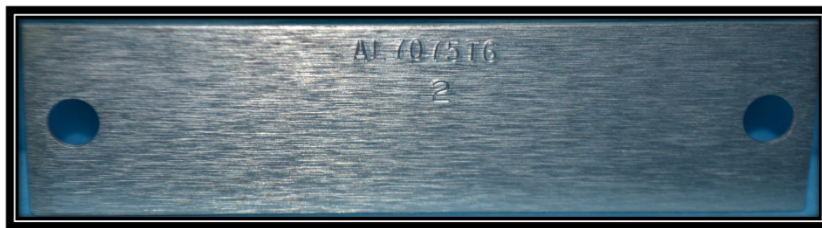
Figure 6: AL7075 T6 after Corrosion Removal

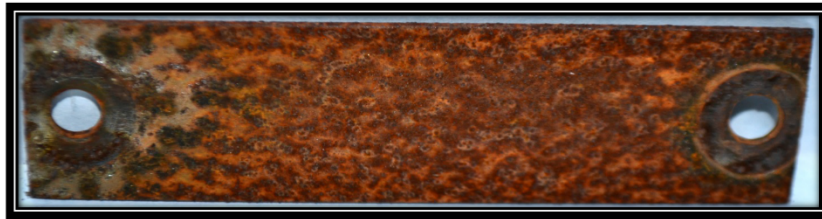
**Figure 7:** C1010 Sample prior to Corrosion Removal

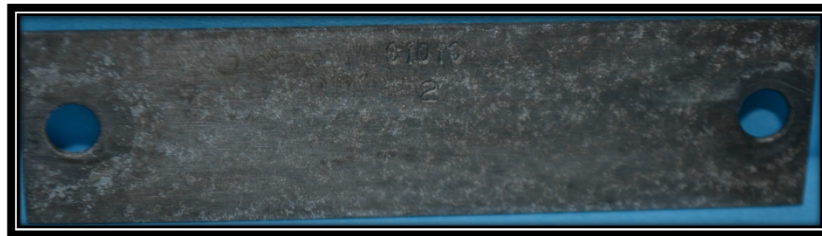
**Figure 8:** C1010 after Corrosion Removal

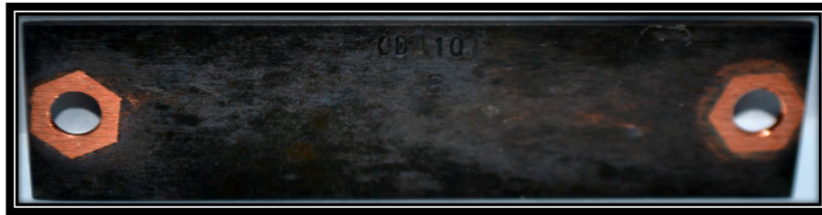
**Figure 9:** CDA101 Sample prior to Corrosion Removal

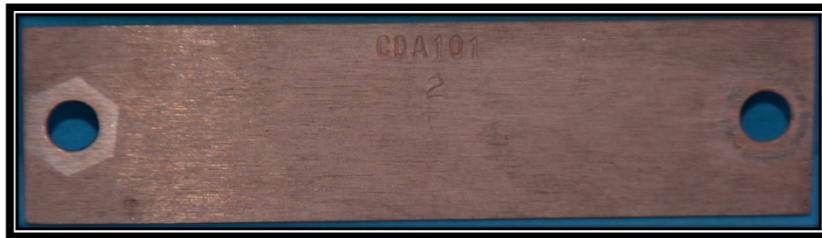
**Figure 10:** CDA101 after Corrosion Removal
